Issue: Damage to CCGS Corporal McLaren M.M.V.

CCGS Corporal McLaren Partially Submerged at Sambro, NS

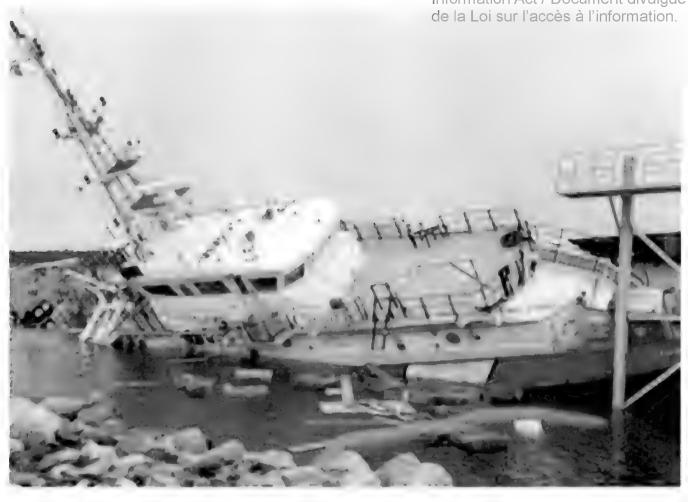
Therefore once the vessel is secured at the wharf then ABS will attend for damage survey.

Picture in link below. Damage will be extensive, ER flooded I should think.

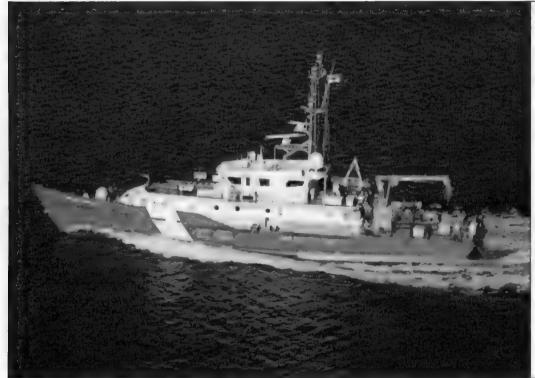
Background: This morning (November 17), The Regional Operations Centre was advised of damage to the CCGS Corporal McLaren. The vessel had been in refit in Sambro, NS at Canadian Maritime Engineering Ltd. Sometime overnight the vessel slid down out of it's secured holding cradle, hit the water and rolled over. The incident is presently under investigation. Vessel currently on its side partially submerged. RCMP are involved as there is a suspicion of vandalism (unconfirmed). Media attention is anticipated.

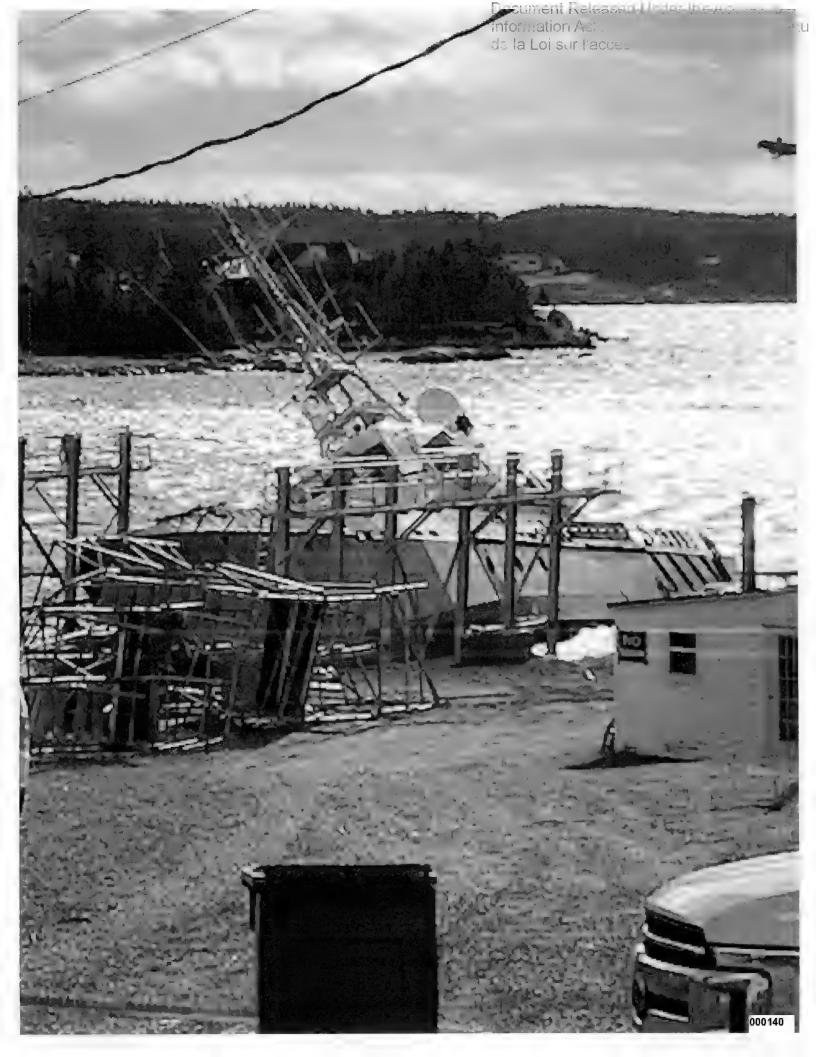
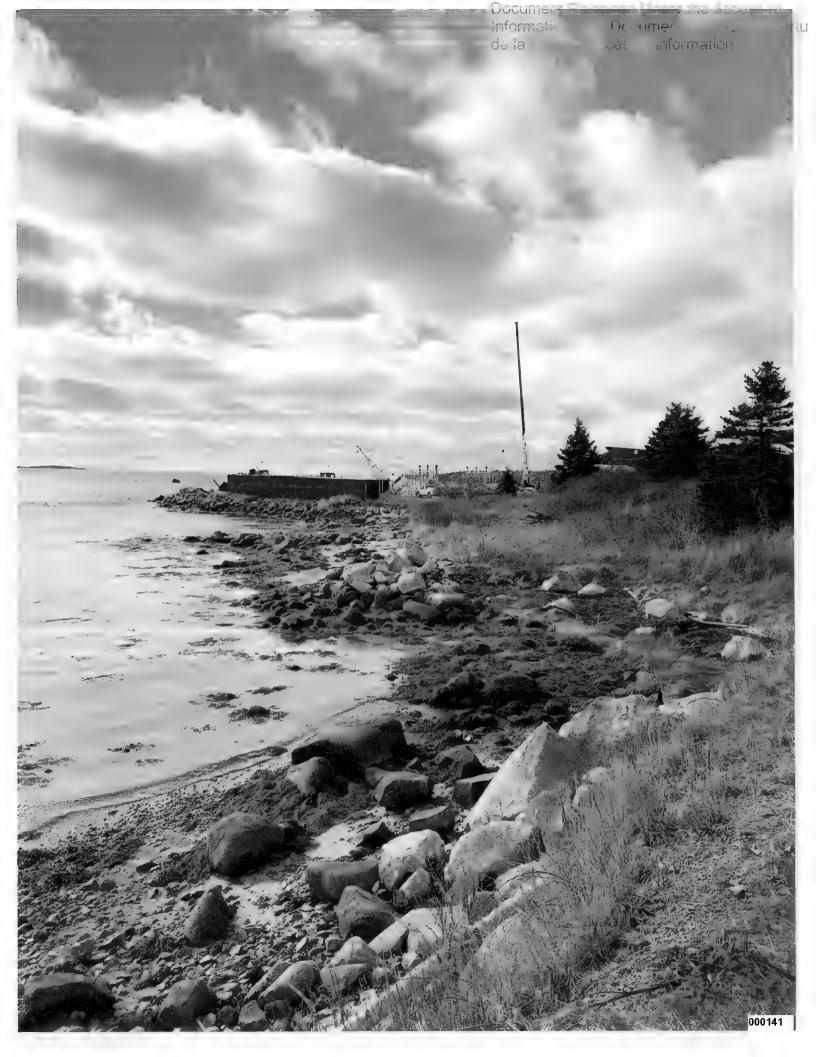
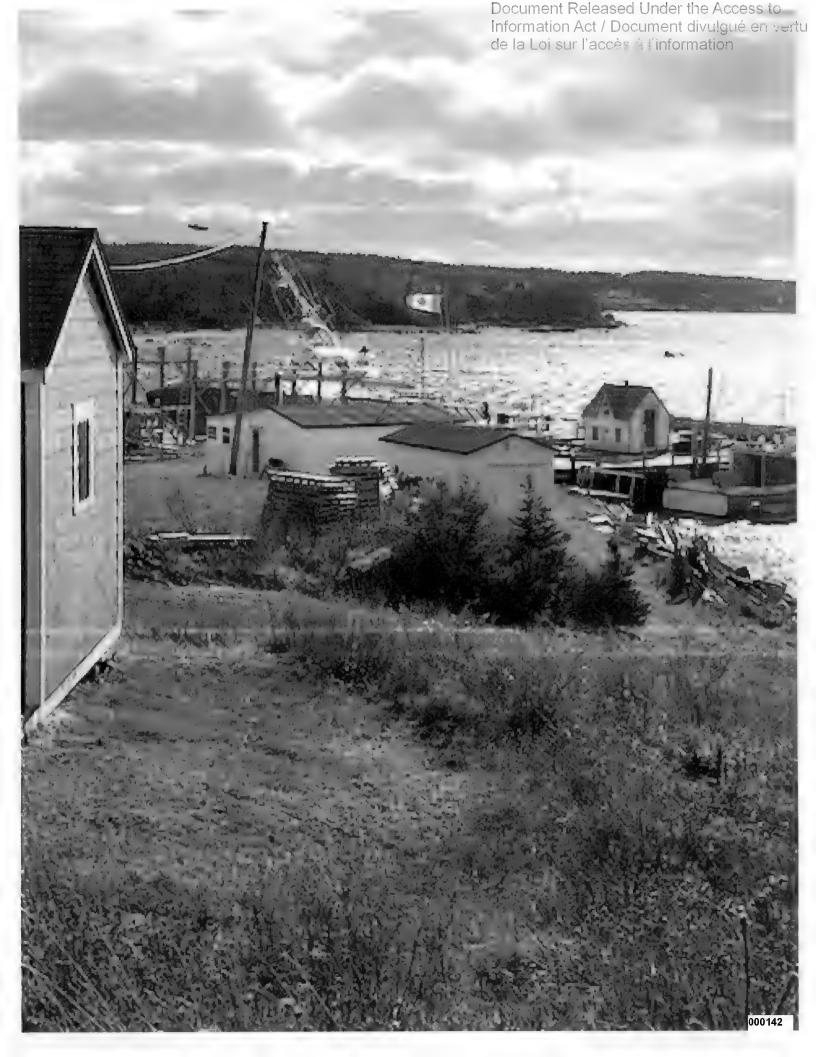
Here are some pictures of the McLaren from the road side

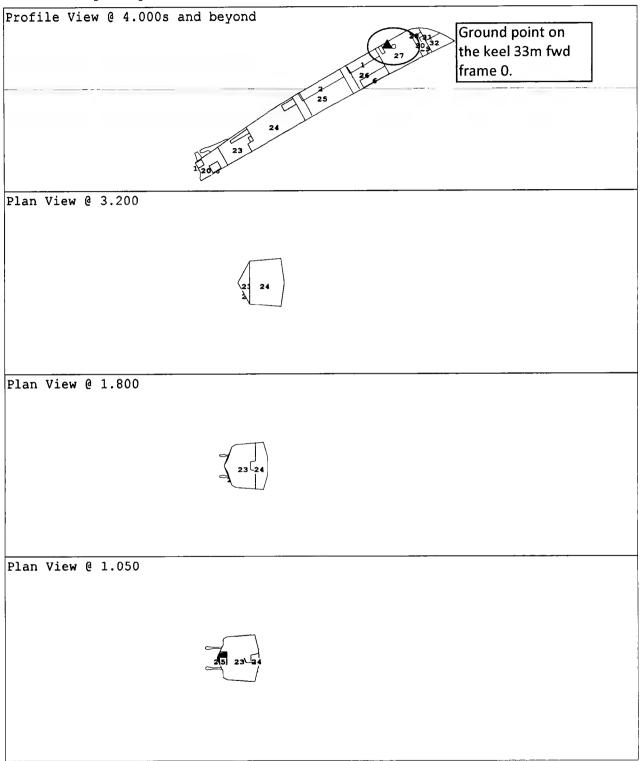
Trim: Aft 20.777/36.700, Heel: Port 179.99 deg. Least freeboard is -13.105 m. located at 0.500a Least extra freeboard (to margin line) is -13.181 m. located at 0.500a CG - Origin Depth: 9.556 Trim: aft 20.777/36.700 Heel: port 179.99 deg.
